# Access Compliance Report Public Rights-of-Way (Pedestrian Signals)

Main Street: **SANTA ANA\_AVE** Cross Street: **MESA\_DR** Location: **SE**

ADA ID: **SGAT220128175142** Signal Type: **One Push Button-Non APS** Overall Compliance: **No** Severity Scores: **BTN 1: 35** **BTN 2: N/A** **No BTN: N/A**

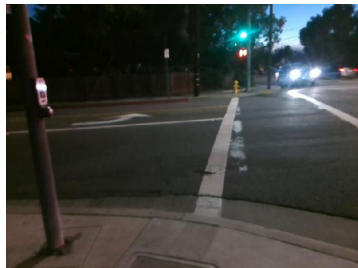
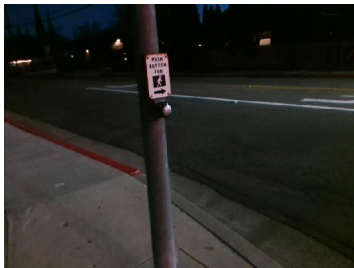
| <b>No</b> B 1 Pilot Light? | <b>No</b> | <b>N/A</b> B 2 Pilot Light? | <b>N/A</b> |

| Compliance | Description | Data | Compliance | Description | Data |
|---|---|---|---|---|---|
| <b>No</b> | B 1 Clear Floor Space Slope (%) | <b>4.8</b> | <b>N/A</b> | B 2 Clear Floor Space Slope (%) | <b>N/A</b> |
| <b>No</b> | B 1 Pressure (#) | <b>9</b> | <b>N/A</b> | B 2 Pressure (#) | <b>N/A</b> |

Possible Solutions: Replace Signal Push Button With APS Button. Remove and Replace Clear Space.
