# Access Compliance Report

## Public Rights-of-Way

### (Pedestrian Signals)

Main Street: BALL\_RD Cross Street: S\_BROOKHURST\_ST Location: SW

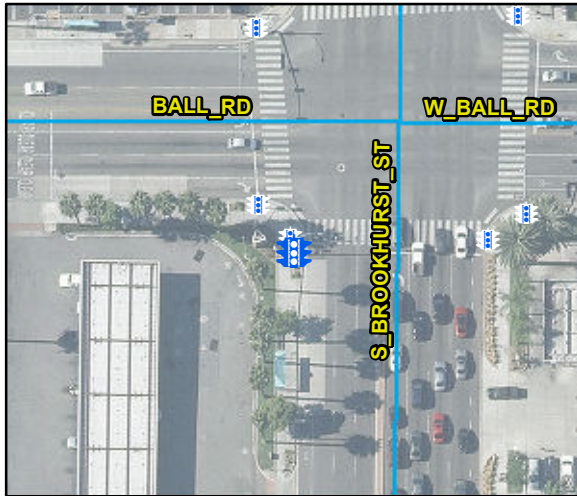
ADA ID: SGAT220202154208 Signal Type: One Push Button-Non APS Overall Compliance: No Severity Scores: BTN 1: 10 BTN 2: N/A No BTN: N/A

| Compliance | Description | Data | Compliance | Description | Data |
|---|---|---|---|---|---|
| No B 1 Pressure (#) | 7 | N/A | B 2 Pressure (#) | N/A | |
| No B 1 Closed Fist Operation? | No | N/A | B 2 Closed Fist Operation? | N/A | |
| No B 1 Diameter (in) | 0.25 | N/A | B 2 Diameter (in) | N/A | |

Possible Solutions: Replace Signal Push Button With APS Button.

OC Std/PROW: R403.4, DMS-11132, R104.2, R209.1, MUTCD 4e.08

Total Cost: \$ 900
