# Access Compliance Report Public Rights-of-Way (Pedestrian Signals)

Main Street: BALL\_RD Cross Street: S\_BROOKHURST\_ST Location: SW

ADA ID: SGAT220202154406 Signal Type: One Push Button-Non APS Overall Compliance: No Severity Scores: BTN 1: 35 BTN 2: N/A No BTN: N/A

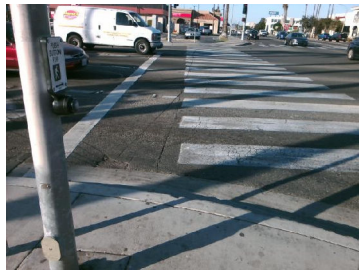
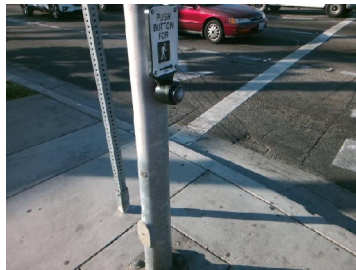
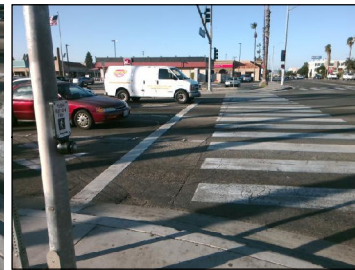
| No B 1 Pilot Light? | No | N/A B 2 Pilot Light? | N/A |

| Compliance | Description | Data | Compliance | Description | Data |
|---|---|---|---|---|---|
| No B 1 Clear Floor Space XSlope (%) | 5.1 | N/A | B 2 Clear Floor Space XSlope (%) | N/A | |

Possible Solutions: Replace Signal Push Button With APS Button. Remove and Replace Clear Space.
