# Access Compliance Report Public Rights-of-Way (Pedestrian Signals)

Main Street: **OSO\_PKWY** Cross Street: **N/A** Location: **S**

ADA ID: **SGAT220208131148** Signal Type: **One Push Button-Non APS** Overall Compliance: **No** Severity Scores: **BTN 1: 35** **BTN 2: N/A** **No BTN: N/A**

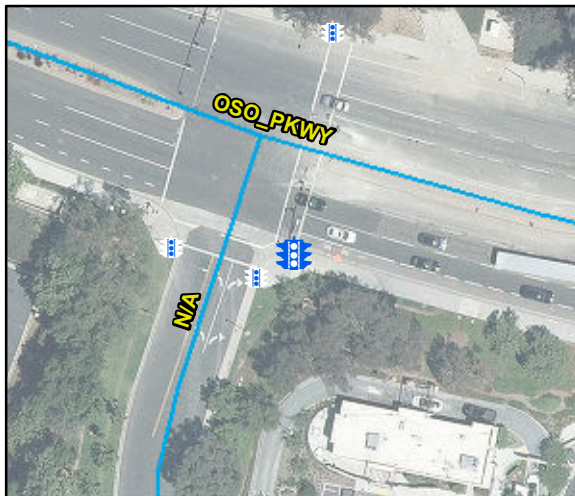
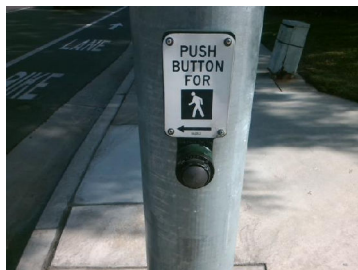
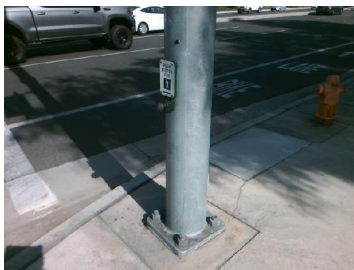
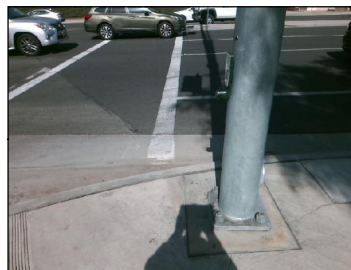
| Compliance | Description | Data | Compliance | Description | Data |
|---|---|---|---|---|---|
| <b>No</b> | B 1 Clear Floor Space Slope (%) | <b>2.77</b> | <b>N/A</b> | B 2 Clear Floor Space Slope (%) | <b>N/A</b> |
| <b>No</b> | B 1 Clear Floor Space XSlope (%) | <b>5.2</b> | <b>N/A</b> | B 2 Clear Floor Space XSlope (%) | <b>N/A</b> |

| <b>No</b> | B 1 Pilot Light? | <b>No</b> | <b>N/A</b> | B 2 Pilot Light? | <b>N/A</b> |

Possible Solutions: Replace Signal Push Button With APS Button. Remove and Replace Clear Space.

OC Std/PROW: **R404.2, R404.3, MUTCD 4e.08**
