# Access Compliance Report Public Rights-of-Way (Pedestrian Signals)

Main Street: YORBA\_LINDA\_BLV Cross Street: YORBA\_LINDA\_BLV Location: N

ADA ID: SGAT220221105825 Signal Type: One Push Button-Non APS Overall Compliance: No Severity Scores: BTN 1: 55 BTN 2: N/A No BTN: N/A

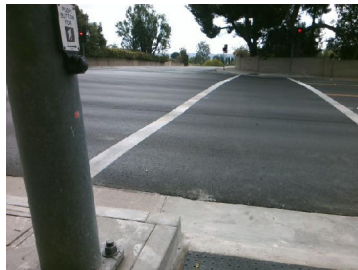
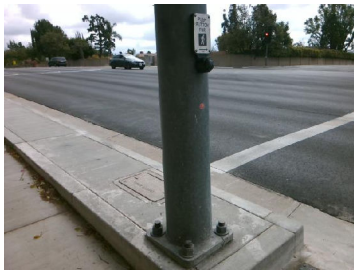
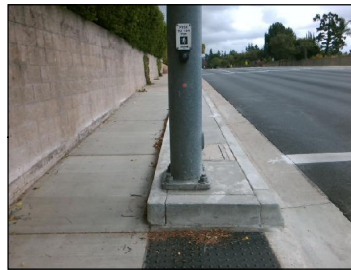
| Compliance | Description | Data | Compliance | Description | Data |
|---|---|---|---|---|---|
| No | B 1 Clear Floor Space XSlope (%) | 3.3 | N/A | B 2 Clear Floor Space XSlope (%) | N/A |
| No | B 1 Height (in) | 53 | N/A | B 2 Height (in) | N/A |

Possible Solutions: Replace Signal Push Button With APS Button. Provide PAR As Indicated. Adjust Signal Button Height. Remove and Replace Clear Space.

OC Std/PROW: R404.3, R404.2, R406, MUTCD 4e.08
