# Access Compliance Report Public Rights-of-Way (Pedestrian Signals)

Main Street: **PALM\_AVE** Cross Street: **YORBA\_LINDA\_BLV** Location: **NW**

ADA ID: **SGAT220223090527** Signal Type: **One Push Button-Non APS** Overall Compliance: **No** Severity Scores: **BTN 1: 35** **BTN 2: N/A** **No BTN: N/A**

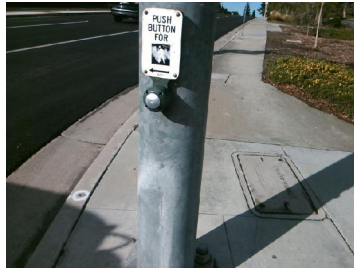
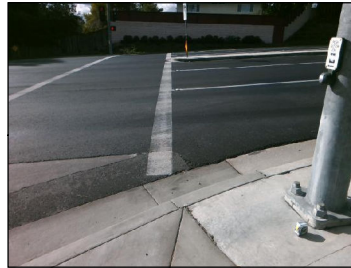
| Compliance | Description | Data | Compliance | Description | Data |
|---|---|---|---|---|---|
| <b>No</b> | B 1 Clear Floor Space Slope (%) | <b>7.3</b> | <b>N/A</b> | B 2 Clear Floor Space Slope (%) | <b>N/A</b> |
| <b>No</b> | B 1 Clear Floor Space XSlope (%) | <b>3</b> | <b>N/A</b> | B 2 Clear Floor Space XSlope (%) | <b>N/A</b> |
| <b>No</b> | B 1 Pressure (#) | <b>6</b> | <b>N/A</b> | B 2 Pressure (#) | <b>N/A</b> |
| <b>No</b> | B 1 DistanceTo Curb (in) | <b>170</b> | <b>N/A</b> | B 2 DistanceTo Curb (in) | <b>N/A</b> |

**Possible Solutions: Replace Signal Push Button With APS Button. Remove & Relocate Sign.**

**OC Std/PROW: MUTCD 4e.08, R404.2, R404.3, R403.4**
