# Access Compliance Report Public Rights-of-Way (Pedestrian Signals)

Main Street: GILBERT\_ST Cross Street: KATELLA\_AVE Location: W

ADA ID: SGRK210916133536 Signal Type: One Push Button-Non APS Overall Compliance: No Severity Scores: BTN 1: 25 BTN 2: N/A No BTN: N/A

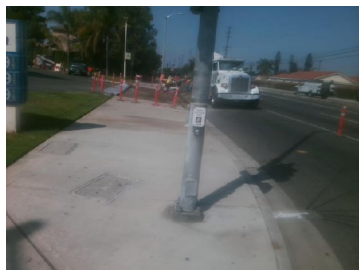
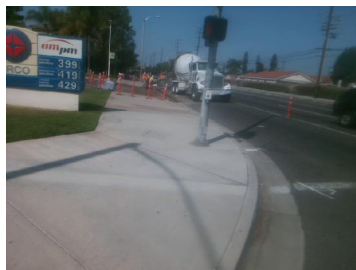
| Compliance | Description | Data | Compliance | Description | Data |
|---|---|---|---|---|---|
| No | B 1 Clear Floor Space Slope (%) | 3.3 | N/A | B 2 Clear Floor Space Slope (%) | N/A |
| No | B 1 DistanceTo XWalk (in) | 65 | N/A | B 2 DistanceTo XWalk (in) | N/A |

Possible Solutions: Replace Signal Push Button With APS Button. Remove & Relocate Sign.
