# Access Compliance Report

## Public Rights-of-Way

### (Pedestrian Signals)

Main Street: CERRITOS\_AVE Cross Street: BROOKHURST\_ST Location: NW

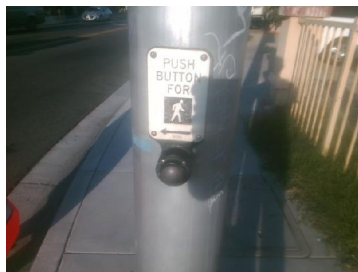
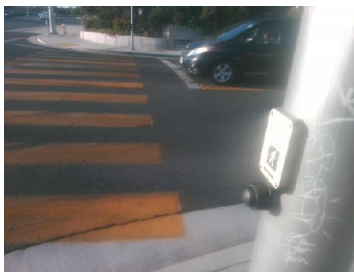
ADA ID: SGRK210923104734 Signal Type: One Push Button-Non APS Overall Compliance: No Severity Scores: BTN 1: 10 BTN 2: N/A No BTN: N/A

| No B 1 Pilot Light? | No | N/A B 2 Pilot Light? | N/A |
| B 1 Addl APS Features? | No | B 2 Addl APS Features? | N/A |

Possible Solutions: Replace Signal Push Button With APS Button.

OC Std/PROW: MUTCD 4e.08

Total Cost: \$ 900
