# Access Compliance Report Public Rights-of-Way (Pedestrian Signals)

Main Street: CERRITOS\_AVE Cross Street: BROOKHURST\_ST Location: SW

ADA ID: SGRK210923105424 Signal Type: One Push Button-Non APS Overall Compliance: No Severity Scores: BTN 1: 35 BTN 2: N/A No BTN: N/A

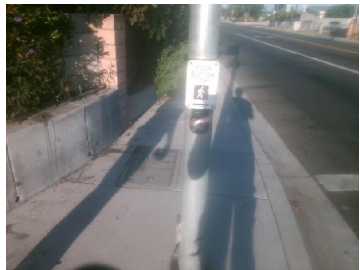
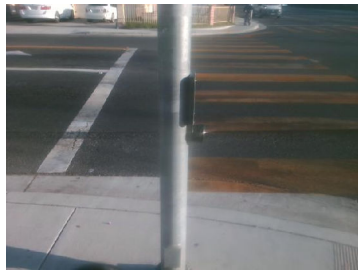
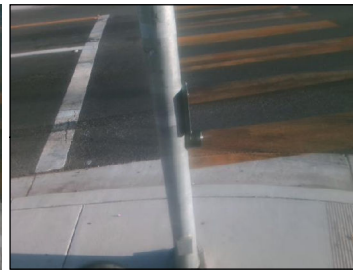
| Compliance | Description | Data | Compliance | Description | Data |
|---|---|---|---|---|---|
| No B 1 Clear Floor Space Slope (%) | 2.5 | N/A | B 2 Clear Floor Space Slope (%) | N/A | |

Possible Solutions: Replace Signal Push Button With APS Button. Remove and Replace Clear Space.
