# Access Compliance Report Public Rights-of-Way (Pedestrian Signals)

Main Street: **CHANTICLEER\_RD** Cross Street: **S\_GILBERT\_ST** Location: **NE**

ADA ID: **SGRK210923122340** Signal Type: **One Push Button-Non APS** Overall Compliance: **No** Severity Scores: **BTN 1: 35** **BTN 2: N/A** **No BTN: N/A**

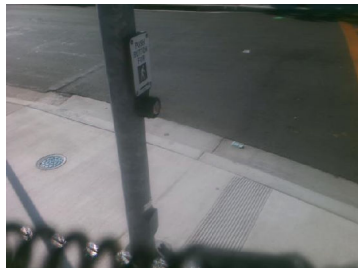
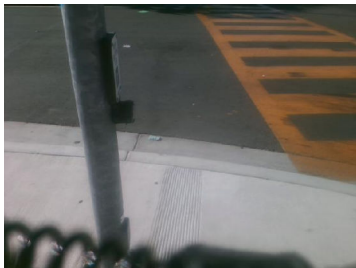
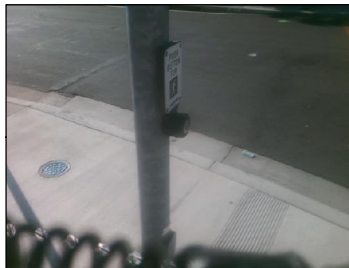
| <b>No</b> B 1 Pilot Light? | <b>No</b> | <b>N/A</b> B 2 Pilot Light? | <b>N/A</b> |

| Compliance | Description | Data | Compliance | Description | Data |
|---|---|---|---|---|---|
| <b>No</b> B 1 Clear Floor Space XSlope (%) | | <b>2.3</b> | <b>N/A</b> | B 2 Clear Floor Space XSlope (%) | <b>N/A</b> |

Possible Solutions: Replace Signal Push Button With APS Button. Remove and Replace Clear Space.

OC Std/PROW: **R404.2, MUTCD 4e.08**

Total Cost: \$ **1278**
