# Access Compliance Report

## Public Rights-of-Way

### (Pedestrian Signals)

Main Street: GILBERT\_ST Cross Street: CHANTICLEER\_RD Location: NE

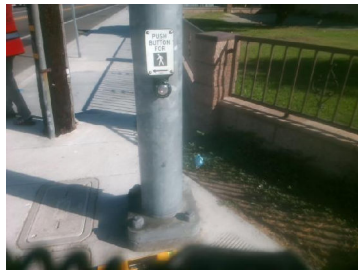
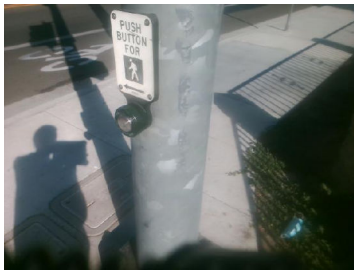
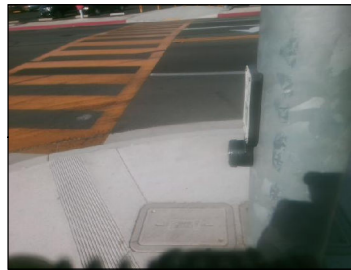
ADA ID: SGRK210923122533 Signal Type: One Push Button-Non APS Overall Compliance: No Severity Scores: BTN 1: 35 BTN 2: N/A No BTN: N/A

| Compliance | Description | Data | Compliance | Description | Data |
|---|---|---|---|---|---|
| No B 1 Clear Floor Space Slope (%) | | 3.2 | N/A | B 2 Clear Floor Space Slope (%) | N/A |
| No B 1 DistanceTo XWalk (in) | | 64 | N/A | B 2 DistanceTo XWalk (in) | N/A |
| No B 1 DistanceTo Curb (in) | | 78 | N/A | B 2 DistanceTo Curb (in) | N/A |

Possible Solutions: Replace Signal Push Button With APS Button. Remove & Relocate Sign.

OC Std/PROW: MUTCD 4e.08, R404.2, R404.3

Total Cost: \$ 650
