# Access Compliance Report Public Rights-of-Way (Pedestrian Signals)

Main Street: CERRITOS\_AVE Cross Street: GILBERT\_ST Location: NE

ADA ID: SGRK210923130910 Signal Type: One Push Button-Non APS Overall Compliance: No Severity Scores: BTN 1: 25 BTN 2: N/A No BTN: N/A

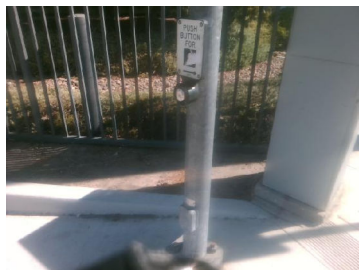
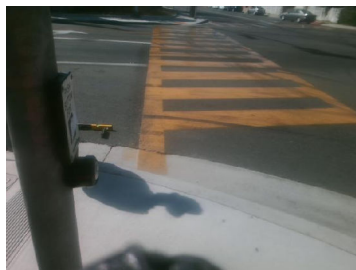
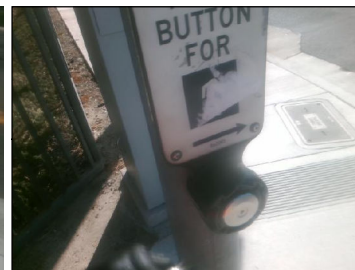
| Compliance | Description | Data | Compliance | Description | Data |
|---|---|---|---|---|---|
| No | B 1 Clear Floor Space Slope (%) | 5.6 | N/A | B 2 Clear Floor Space Slope (%) | N/A |
| No | B 1 Clear Floor Space XSlope (%) | 8 | N/A | B 2 Clear Floor Space XSlope (%) | N/A |

Possible Solutions: Remove and Replace Clear Space.

OC Std/PROW: R404.2, R404.3
