# Access Compliance Report Public Rights-of-Way (Pedestrian Signals)

Main Street: CERRITOS\_AVE Cross Street: GILBERT\_ST Location: SE

ADA ID: SGRK210923131405 Signal Type: One Push Button-Non APS Overall Compliance: No Severity Scores: BTN 1: 25 BTN 2: N/A No BTN: N/A

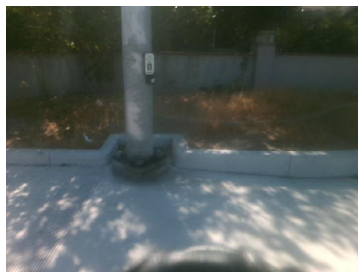
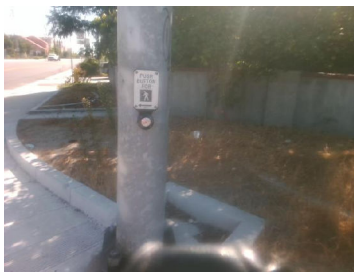
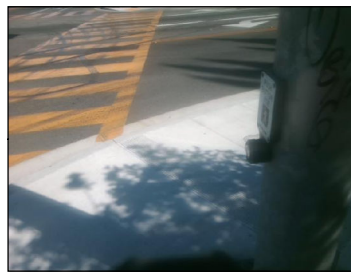
| Compliance | Description | Data | Compliance | Description | Data |
|---|---|---|---|---|---|
| No B 1 Clear Floor Space XSlope (%) | 7.7 | N/A | B 2 Clear Floor Space XSlope (%) | N/A | |
| No B 1 DistanceTo Curb (in) | 85 | N/A | B 2 DistanceTo Curb (in) | N/A | |

Possible Solutions: Replace Signal Push Button With APS Button. Remove & Relocate Sign.
