# Access Compliance Report Public Rights-of-Way (Pedestrian Signals)

Main Street: CERRITOS\_AVE Cross Street: GILBERT\_ST Location: NW

ADA ID: SGRK210923133012 Signal Type: One Push Button-Non APS Overall Compliance: No Severity Scores: BTN 1: 0 BTN 2: N/A No BTN: N/A

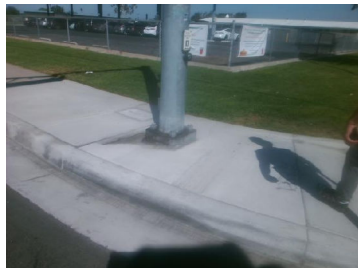
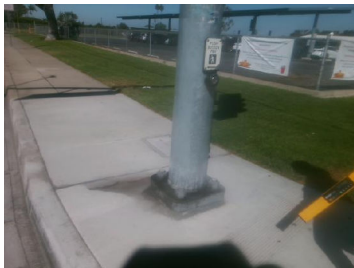
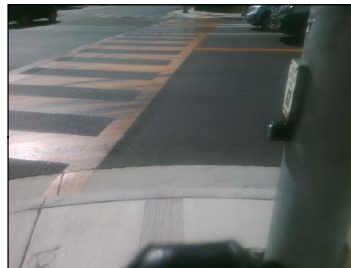
| Compliance | Description | Data | Compliance | Description | Data |
|---|---|---|---|---|---|
| No B 1 DistanceTo XWalk (in) | 66 | N/A | B 2 DistanceTo XWalk (in) | N/A | |

Possible Solutions: Replace Signal Push Button With APS Button. Remove & Relocate Sign.

Total Cost: \$ 650
