# Access Compliance Report Public Rights-of-Way (Pedestrian Signals)

Main Street: PERDIDO\_ST Cross Street: BALL\_RD Location: SE

ADA ID: SGRK210923172427 Signal Type: One Push Button-Non APS Overall Compliance: No Severity Scores: BTN 1: 35 BTN 2: N/A No BTN: N/A

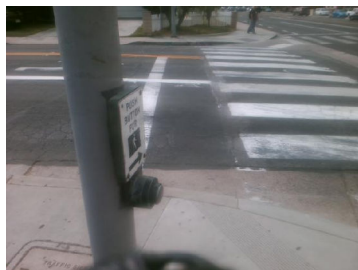
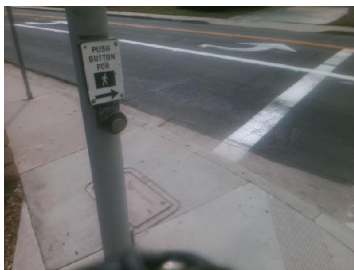
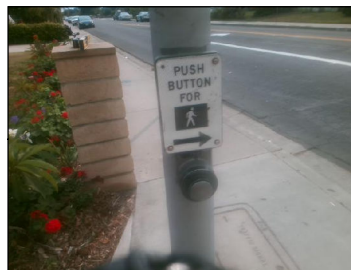
| No B 1 Pilot Light? | No | N/A B 2 Pilot Light? | N/A |

| Compliance | Description | Data | Compliance | Description | Data |
|---|---|---|---|---|---|
| No | B 1 Clear Floor Space XSlope (%) | 4.9 | N/A | B 2 Clear Floor Space XSlope (%) | N/A |

Possible Solutions: Replace Signal Push Button With APS Button. Remove and Replace Clear Space.
