# Access Compliance Report Public Rights-of-Way (Pedestrian Signals)

Main Street: GILBERT\_ST Cross Street: W\_ORANGE\_AVE Location: SE

ADA ID: SGRK210927113019 Signal Type: One Push Button-Non APS Overall Compliance: No Severity Scores: BTN 1: 35 BTN 2: N/A No BTN: N/A

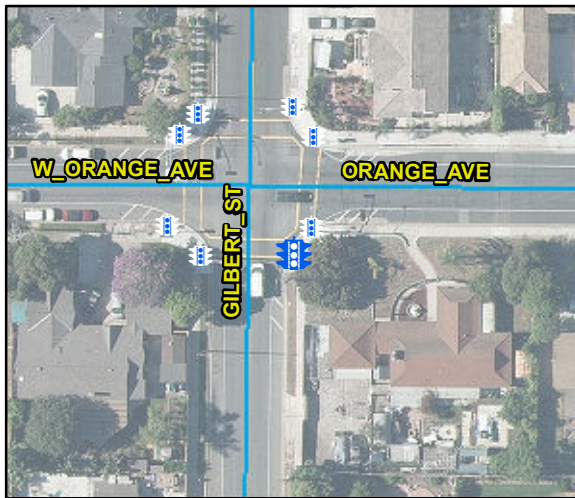
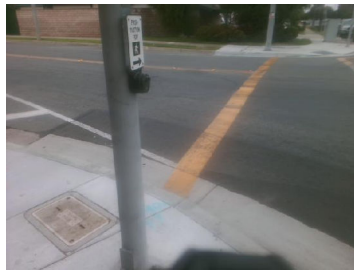
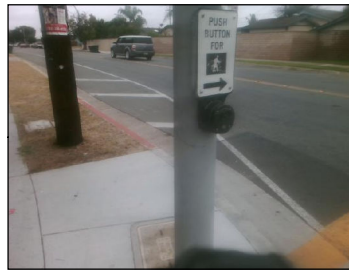
| Compliance | Description | Data | Compliance | Description | Data |
|---|---|---|---|---|---|
| No B 1 Clear Floor Space XSlope (%) | | 12.9 | N/A | B 2 Clear Floor Space XSlope (%) | N/A |

Possible Solutions: Replace Signal Push Button With APS Button. Remove and Replace Clear Space.

OC Std/PROW: R404.2, MUTCD 4e.08
