# Access Compliance Report Public Rights-of-Way (Pedestrian Signals)

Main Street: **ORANGE\_AVE** Cross Street: **GILBERT\_ST** Location: **SE**

ADA ID: **SGRK210927113245** Signal Type: **One Push Button-Non APS** Overall Compliance: **No** Severity Scores: **BTN 1: 35** **BTN 2: N/A** **No BTN: N/A**

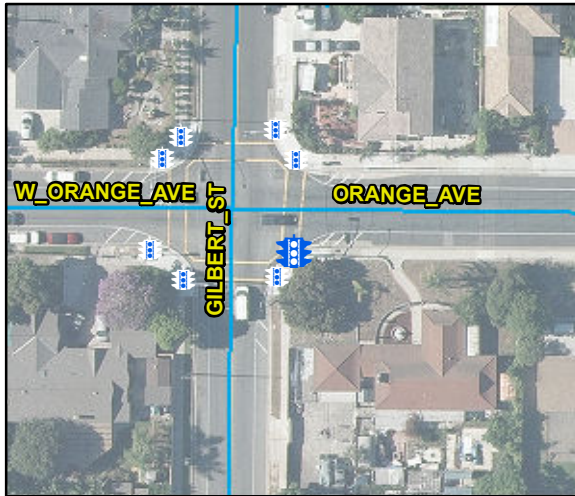
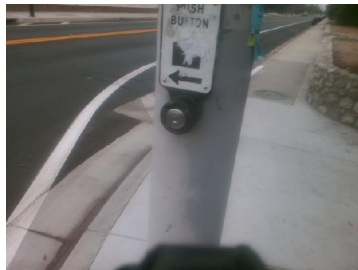
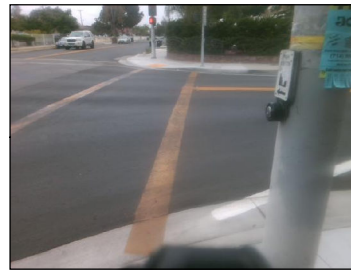
| <b>No</b> B 1 VibroTact Parallel to Xing? | <b>N/A</b> | <b>N/A</b> B 2 VibroTact Parallel to Xing? | <b>N/A</b> |

| Compliance | Description | Data | Compliance | Description | Data |
|---|---|---|---|---|---|
| <b>No</b> B 1 Clear Floor Space XSlope (%) | | <b>2.9</b> | <b>N/A</b> | B 2 Clear Floor Space XSlope (%) | <b>N/A</b> |

Possible Solutions: Replace Signal Push Button With APS Button. Remove and Replace Clear Space.

OC Std/PROW: **R404.2, MUTCD 4e.08**
