# Access Compliance Report Public Rights-of-Way (Pedestrian Signals)

Main Street: **ORANGE\_AVE** Cross Street: **GILBERT\_ST** Location: **NE**

ADA ID: **SGRK210927113649** Signal Type: **One Push Button-Non APS** Overall Compliance: **No** Severity Scores: **BTN 1: 35** **BTN 2: N/A** **No BTN: N/A**

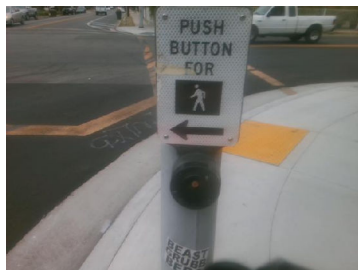
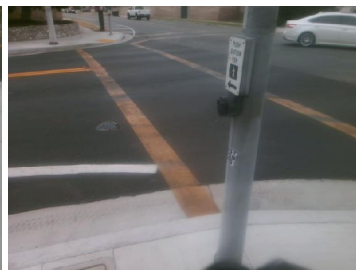
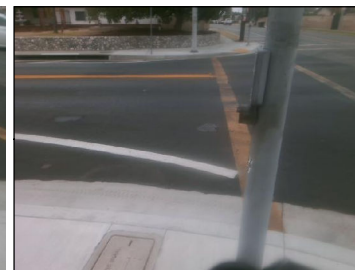
| Compliance | Description | Data | Compliance | Description | Data |
|---|---|---|---|---|---|
| <b>No</b> B 1 Clear Floor Space XSlope (%) | | <b>9</b> | <b>N/A</b> | B 2 Clear Floor Space XSlope (%) | <b>N/A</b> |
| <b>No</b> B 1 Closed Fist Operation? | | <b>No</b> | <b>N/A</b> | B 2 Closed Fist Operation? | <b>N/A</b> |
| <b>No</b> B 1 Diameter (in) | | <b>0.25</b> | <b>N/A</b> | B 2 Diameter (in) | <b>N/A</b> |

Possible Solutions: Replace Signal Push Button With APS Button. Remove and Replace Clear Space.
