# Access Compliance Report Public Rights-of-Way (Pedestrian Signals)

Main Street: GILBERT\_ST Cross Street: ORANGE\_AVE Location: NE

ADA ID: SGRK210927113843 Signal Type: One Push Button-Non APS Overall Compliance: No Severity Scores: BTN 1: 25 BTN 2: N/A No BTN: N/A

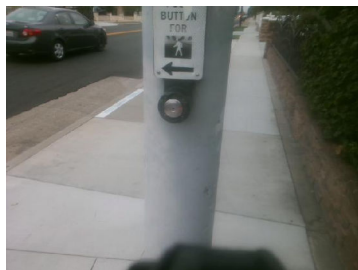
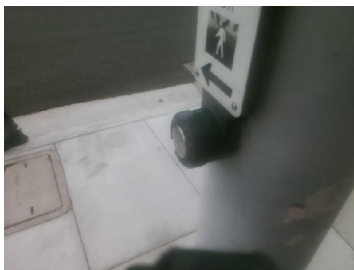
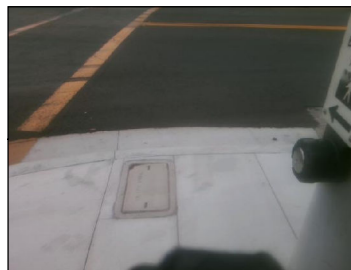
| Compliance | Description | Data | Compliance | Description | Data |
|---|---|---|---|---|---|
| No B 1 Clear Floor Space XSlope (%) | | 5.4 | N/A | B 2 Clear Floor Space XSlope (%) | N/A |
| No B 1 DistanceTo XWalk (in) | | 82 | N/A | B 2 DistanceTo XWalk (in) | N/A |

Possible Solutions: Replace Signal Push Button With APS Button. Remove & Relocate Sign.

OC Std/PROW: MUTCD 4e.08, R404.2

Total Cost: \$ 650
