# Access Compliance Report Public Rights-of-Way (Pedestrian Signals)

Main Street: **S\_BROOKHURST\_ST** Cross Street: **ORANGE\_AVE** Location: **SW**

ADA ID: **SGRK210927121432** Signal Type: **One Push Button-Non APS** Overall Compliance: **No** Severity Scores: **BTN 1: 55** **BTN 2: N/A** **No BTN: N/A**

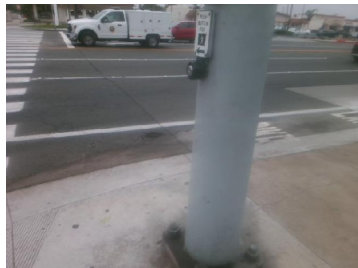
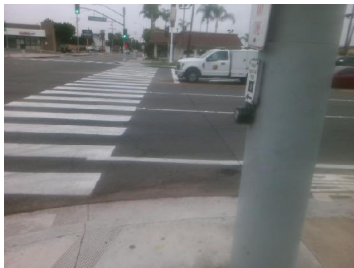
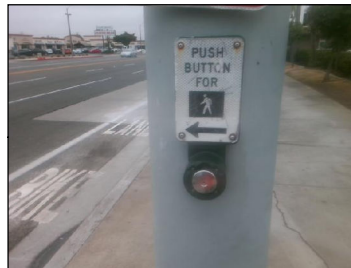
| Compliance | Description | Data | Compliance | Description | Data |
|---|---|---|---|---|---|
| <b>No</b> | B 1 Clear Floor Space XSlope (%) | <b>2.1</b> | <b>N/A</b> | B 2 Clear Floor Space XSlope (%) | <b>N/A</b> |
| <b>No</b> | B 1 Height (in) | <b>49</b> | <b>N/A</b> | B 2 Height (in) | <b>N/A</b> |
| <b>No</b> | B 1 DistanceTo XWalk (in) | <b>64</b> | <b>N/A</b> | B 2 DistanceTo XWalk (in) | <b>N/A</b> |

Possible Solutions: Replace Signal Push Button With APS Button. Remove & Relocate Sign. Adjust Signal Button Height.

OC Std/PROW: **MUTCD 4e.08, R404.2, R406**

Total Cost: \$ **1150**
