# Access Compliance Report Public Rights-of-Way (Pedestrian Signals)

Main Street: **BROOKHURST\_ST** Cross Street: **ORANGE\_AVE** Location: **NW**

ADA ID: **SGRK210927122406** Signal Type: **One Push Button-Non APS** Overall Compliance: **No** Severity Scores: **BTN 1: 25** **BTN 2: N/A** **No BTN: N/A**

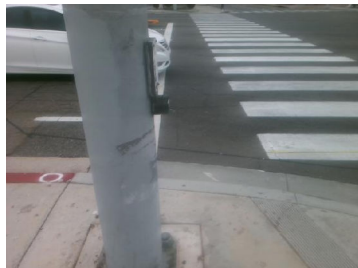
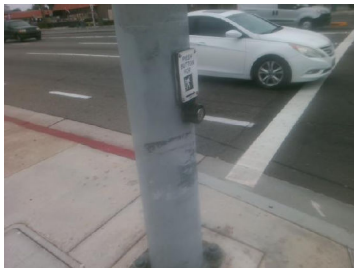
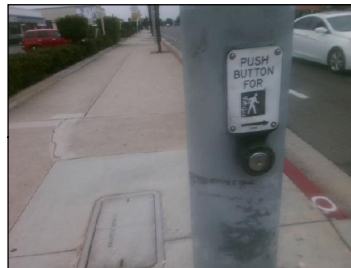
| Compliance | Description | Data | Compliance | Description | Data |
|---|---|---|---|---|---|
| <b>No</b> | B 1 Clear Floor Space XSlope (%) | <b>3.9</b> | <b>N/A</b> | B 2 Clear Floor Space XSlope (%) | <b>N/A</b> |

Possible Solutions: Remove and Replace Clear Space.

OC Std/PROW: **R404.2**
