# Access Compliance Report Public Rights-of-Way (Pedestrian Signals)

Main Street: BALL\_RD Cross Street: GILBERT\_ST Location: NE

ADA ID: SGRK210927171332 Signal Type: One Push Button-Non APS Overall Compliance: No Severity Scores: BTN 1: 35 BTN 2: N/A No BTN: N/A

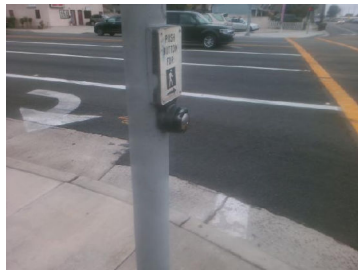
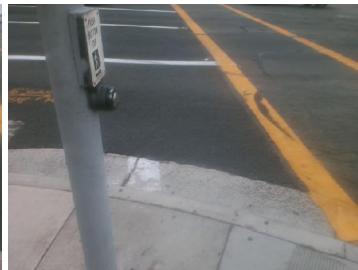
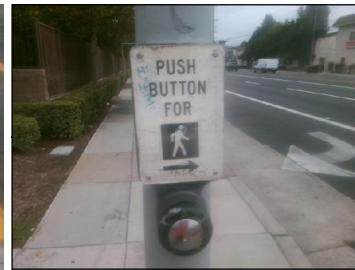
| No B 1 Pilot Light? | No | N/A B 2 Pilot Light? | N/A |

| Compliance | Description | Data | Compliance | Description | Data |
|---|---|---|---|---|---|
| No B 1 Clear Floor Space XSlope (%) | 4.9 | N/A | B 2 Clear Floor Space XSlope (%) | N/A | |
| No B 1 DistanceTo XWalk (in) | 70 | N/A | B 2 DistanceTo XWalk (in) | N/A | |

Possible Solutions: Replace Signal Push Button With APS Button. Remove & Relocate Sign.
