# Access Compliance Report Public Rights-of-Way (Pedestrian Signals)

Main Street: **W BALL RD** Cross Street: **GILBERT ST** Location: **SW**

ADA ID: **SGRK210927172837** Signal Type: **One Push Button-Non APS** Overall Compliance: **No** Severity Scores: **BTN 1: 35** **BTN 2: N/A** **No BTN: N/A**

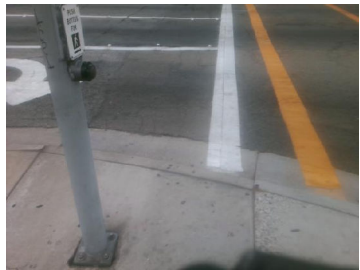
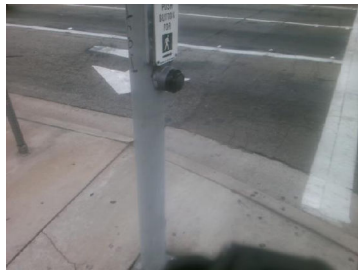
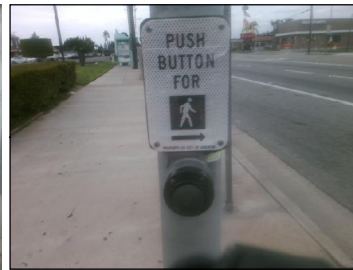
| <b>No</b> B 1 Pilot Light? | <b>No</b> | <b>N/A</b> B 2 Pilot Light? | <b>N/A</b> |

| Compliance | Description | Data | Compliance | Description | Data |
|---|---|---|---|---|---|
| <b>No</b> | B 1 Clear Floor Space XSlope (%) | <b>2.9</b> | <b>N/A</b> | B 2 Clear Floor Space XSlope (%) | <b>N/A</b> |

Possible Solutions: Replace Signal Push Button With APS Button. Remove and Replace Clear Space.

OC Std/PROW: **R404.2, MUTCD 4e.08**

Total Cost: \$ **1278**
