# Access Compliance Report Public Rights-of-Way (Pedestrian Signals)

Main Street: DALE\_ST Cross Street: ORANGEWOOD\_AVE Location: SW

ADA ID: SGRK210927181652 Signal Type: One Push Button-Non APS Overall Compliance: No Severity Scores: BTN 1: 35 BTN 2: N/A No BTN: N/A

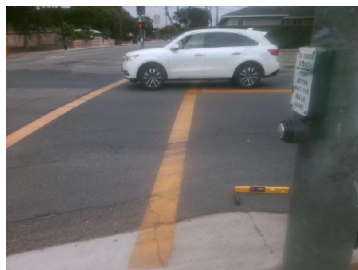
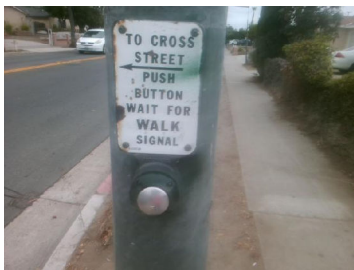
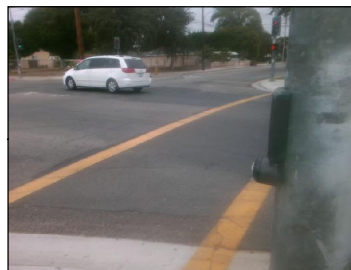
| Compliance | Description | Data | Compliance | Description | Data |
|---|---|---|---|---|---|
| No | B 1 Clear Floor Space XSlope (%) | 2.2 | N/A | B 2 Clear Floor Space XSlope (%) | N/A |

| No | B 1 Pilot Light? | No | N/A | B 2 Pilot Light? | N/A |

Possible Solutions: Replace Signal Push Button With APS Button. Remove and Replace Clear Space.

OC Std/PROW: R404.2, MUTCD 4e.08
