# Access Compliance Report

## Public Rights-of-Way

### (Pedestrian Signals)

Main Street: DALE\_ST Cross Street: ORANGEWOOD\_AVE Location: SE

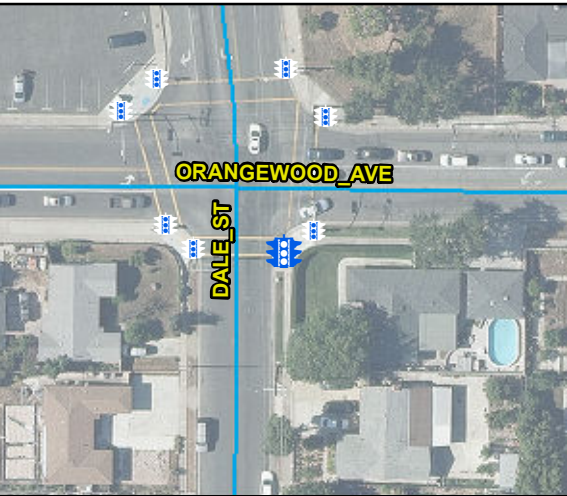
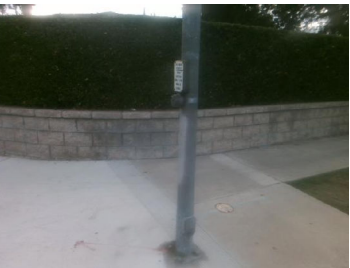
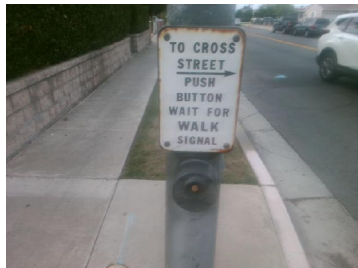
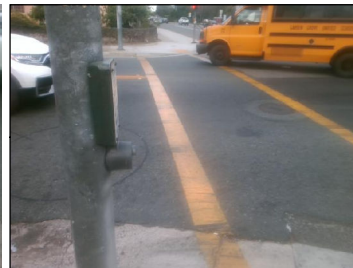
ADA ID: SGRK210928110633 Signal Type: One Push Button-Non APS Overall Compliance: No Severity Scores: BTN 1: 35 BTN 2: N/A No BTN: N/A

| Compliance | Description | Data | Compliance | Description | Data |
|---|---|---|---|---|---|
| No B 1 Clear Floor Space XSlope (%) | 3.7 | N/A | B 2 Clear Floor Space XSlope (%) | N/A | |
| No B 1 Closed Fist Operation? | No | N/A | B 2 Closed Fist Operation? | N/A | |
| No B 1 Diameter (in) | 0.25 | N/A | B 2 Diameter (in) | N/A | |

Possible Solutions: Replace Signal Push Button With APS Button. Remove and Replace Clear Space.

OC Std/PROW: R404.2, DMS-11132, R104.2, R209.1, MUTCD 4e.08
