# Access Compliance Report Public Rights-of-Way (Pedestrian Signals)

Main Street: **ORANGEWOOD\_AVE** Cross Street: **DALE\_ST** Location: **NE**

ADA ID: **SGRK210928111448** Signal Type: **One Push Button-Non APS** Overall Compliance: **No** Severity Scores: **BTN 1: 35** **BTN 2: N/A** **No BTN: N/A**

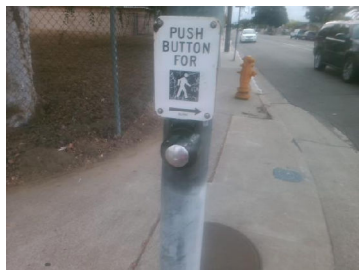
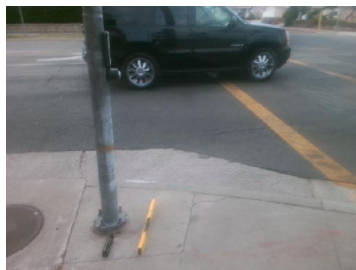
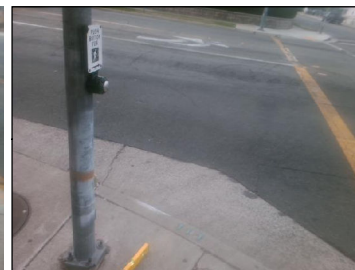
| <b>No</b> B 1 Pilot Light? | <b>No</b> | <b>N/A</b> B 2 Pilot Light? | <b>N/A</b> |

| Compliance | Description | Data | Compliance | Description | Data |
|---|---|---|---|---|---|
| <b>No</b> | B 1 Clear Floor Space XSlope (%) | <b>2.4</b> | <b>N/A</b> | B 2 Clear Floor Space XSlope (%) | <b>N/A</b> |
| <b>No</b> | B 1 DistanceTo XWalk (in) | <b>100</b> | <b>N/A</b> | B 2 DistanceTo XWalk (in) | <b>N/A</b> |

**Possible Solutions: Replace Signal Push Button With APS Button. Remove & Relocate Sign.**

**OC Std/PROW: MUTCD 4e.08, R404.2**
