# Access Compliance Report Public Rights-of-Way (Pedestrian Signals)

Main Street: ORANGEWOOD\_AVE Cross Street: ORANGEWOOD\_AVE Location: N

ADA ID: SGRK210928115537 Signal Type: Two Push Buttons-Non APS Overall Compliance: No Severity Scores: BTN 1: 60 BTN 2: 60 No BTN: N/A

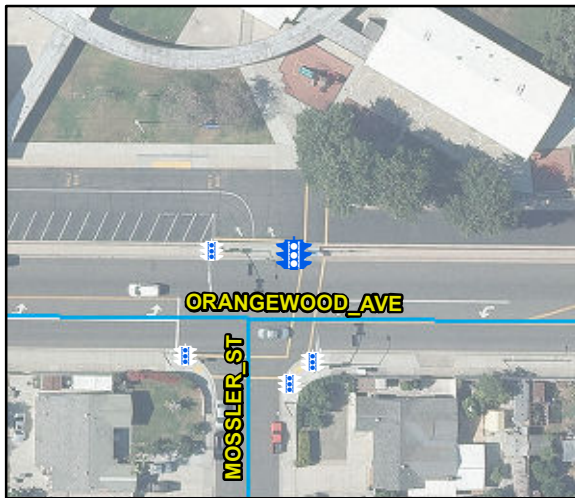
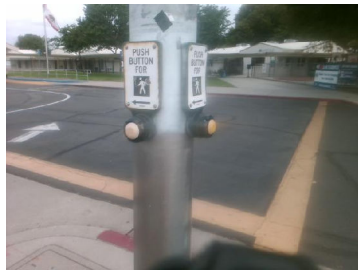
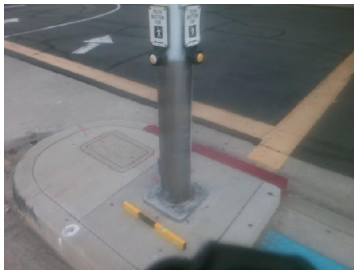
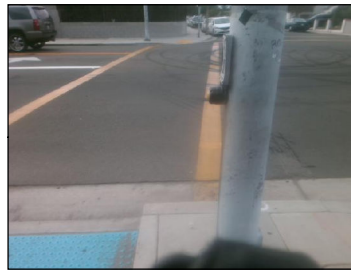
| Compliance | Description | Data | Compliance | Description | Data |
|---|---|---|---|---|---|
| No | B 1 Clear Floor Space? | Yes | No | B 2 Clear Floor Space? | Yes |
| No | B 1 FWD Approach Reach (in) | 30 | No | B 2 FWD Approach Reach (in) | 25 |
| No | B 1 Clear Floor Space XSlope (%) | 5.2 | No | B 2 Clear Floor Space XSlope (%) | 5.1 |

| No | B 1 Pilot Light? | No | No | B 2 Pilot Light? | No |

Possible Solutions: Replace Signal Push Button With APS Button. Remove & Relocate Sign. Remove and Replace Clear Space.
