# Access Compliance Report Public Rights-of-Way (Pedestrian Signals)

Main Street: **BEACH\_BLV** Cross Street: **CHAPMAN\_AVE** Location: **SE**

ADA ID: **SGRK210928151922** Signal Type: **One Push Button-APS** Overall Compliance: **No** Severity Scores: **BTN 1: 25** **BTN 2: N/A** **No BTN: N/A**

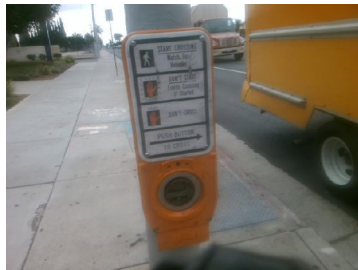
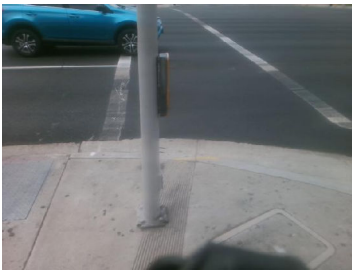
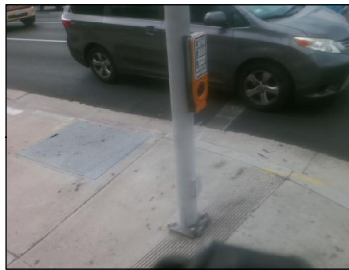
| Compliance | Description | Data | Compliance | Description | Data |
|---|---|---|---|---|---|
| <b>No</b> | B 1 Clear Floor Space XSlope (%) | <b>7.8</b> | <b>N/A</b> | B 2 Clear Floor Space XSlope (%) | <b>N/A</b> |

Possible Solutions: Remove and Replace Clear Space.

OC Std/PROW: **R404.2**

Total Cost: \$ **378**
