# Access Compliance Report Public Rights-of-Way (Pedestrian Signals)

Main Street: **BEACH\_BLV** Cross Street: **CHAPMAN\_AVE** Location: **NE**

ADA ID: **SGRK210928152748** Signal Type: **One Push Button-APS** Overall Compliance: **No** Severity Scores: **BTN 1: 25** **BTN 2: N/A** **No BTN: N/A**

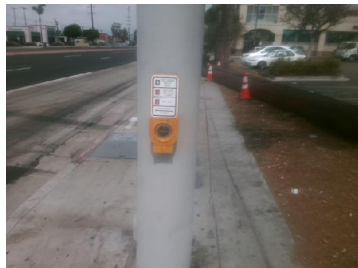
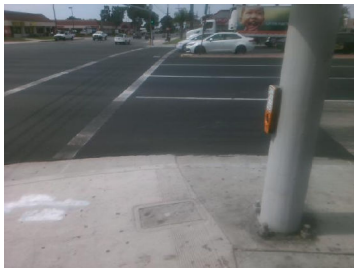
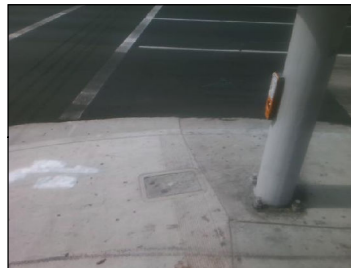
| Compliance | Description | Data | Compliance | Description | Data |
|---|---|---|---|---|---|
| <b>No</b> | B 1 Clear Floor Space Slope (%) | <b>3.7</b> | <b>N/A</b> | B 2 Clear Floor Space Slope (%) | <b>N/A</b> |
| <b>No</b> | B 1 Clear Floor Space XSlope (%) | <b>3.5</b> | <b>N/A</b> | B 2 Clear Floor Space XSlope (%) | <b>N/A</b> |
| <b>No</b> | B 1 DistanceTo XWalk (in) | <b>80</b> | <b>N/A</b> | B 2 DistanceTo XWalk (in) | <b>N/A</b> |

Possible Solutions: Replace Signal Push Button With APS Button. Remove & Relocate Sign.
