# Access Compliance Report Public Rights-of-Way (Pedestrian Signals)

Main Street: CHAPMAN\_AVE Cross Street: CHAPMAN\_AVE Location: SW

ADA ID: SGRK210928172850 Signal Type: One Push Button-Non APS Overall Compliance: No Severity Scores: BTN 1: 10 BTN 2: N/A No BTN: N/A

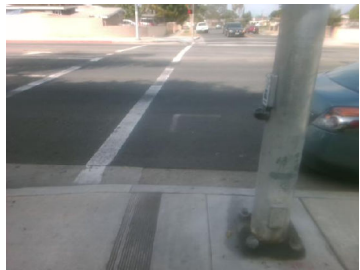
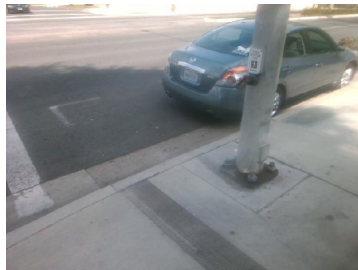
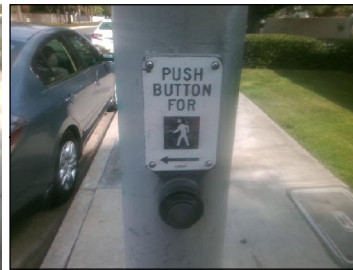
| No B 1 Pilot Light? | No | N/A B 2 Pilot Light? | N/A |

| Compliance | Description | Data | Compliance | Description | Data |
|---|---|---|---|---|---|
| No | B 1 DistanceTo XWalk (in) | 72 | N/A | B 2 DistanceTo XWalk (in) | N/A |

Possible Solutions: Replace Signal Push Button With APS Button. Remove & Relocate Sign.
