# Access Compliance Report Public Rights-of-Way (Pedestrian Signals)

Main Street: **CHAPMAN\_AVE** Cross Street: **NEARING\_DR** Location: **NW**

ADA ID: **SGRK210928173511** Signal Type: **One Push Button-Non APS** Overall Compliance: **No** Severity Scores: **BTN 1: 35** **BTN 2: N/A** **No BTN: N/A**

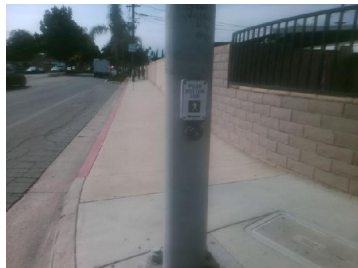
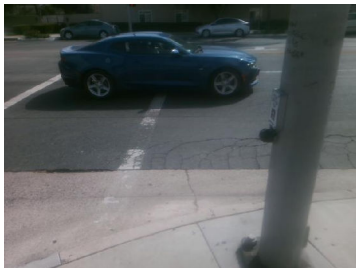
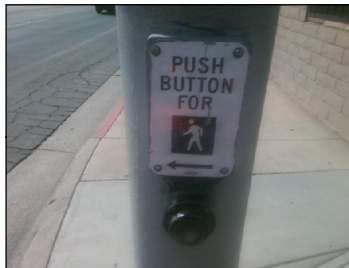
| <b>No</b> B 1 Pilot Light? | <b>No</b> | <b>N/A</b> B 2 Pilot Light? | <b>N/A</b> |

| Compliance | Description | Data | Compliance | Description | Data |
|---|---|---|---|---|---|
| <b>No</b> | B 1 Clear Floor Space Slope (%) | <b>6.6</b> | <b>N/A</b> | B 2 Clear Floor Space Slope (%) | <b>N/A</b> |
| <b>No</b> | B 1 Clear Floor Space XSlope (%) | <b>3.1</b> | <b>N/A</b> | B 2 Clear Floor Space XSlope (%) | <b>N/A</b> |

Possible Solutions: Replace Signal Push Button With APS Button. Remove and Replace Clear Space.

OC Std/PROW: **R404.2, R404.3, MUTCD 4e.08**
