# Access Compliance Report Public Rights-of-Way (Pedestrian Signals)

Main Street: NEWLAND\_ST Cross Street: HAZARD\_AVE Location: SW

ADA ID: SGRK210929113120 Signal Type: One Push Button-Non APS Overall Compliance: No Severity Scores: BTN 1: 35 BTN 2: N/A No BTN: N/A

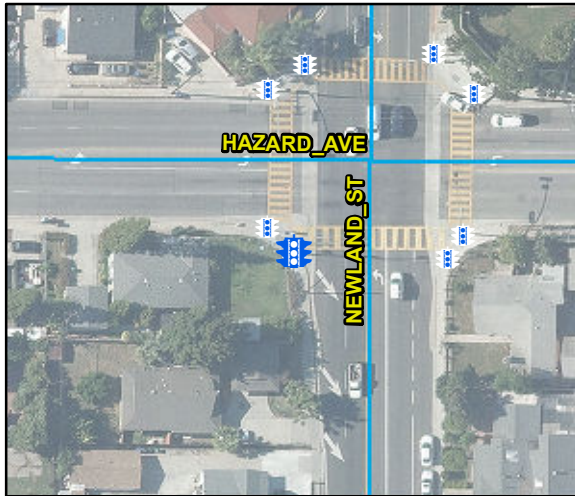
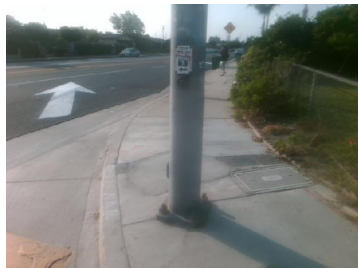
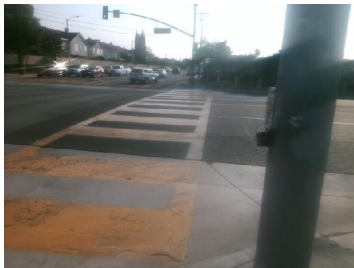
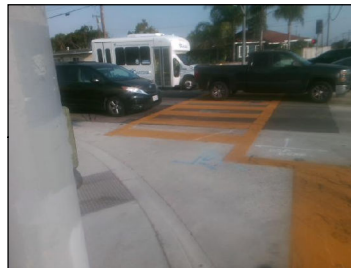
| Compliance | Description | Data | Compliance | Description | Data |
|---|---|---|---|---|---|
| No | B 1 Clear Floor Space XSlope (%) | 8.1 | N/A | B 2 Clear Floor Space XSlope (%) | N/A |

| No | B 1 Pilot Light? | No | N/A | B 2 Pilot Light? | N/A |

Possible Solutions: Replace Signal Push Button With APS Button. Remove and Replace Clear Space.
