# Access Compliance Report Public Rights-of-Way (Pedestrian Signals)

Main Street: **NEWLAND\_ST** Cross Street: **HAZARD\_AVE** Location: **SW**

ADA ID: **SGRK210929113741** Signal Type: **One Push Button-Non APS** Overall Compliance: **No** Severity Scores: **BTN 1: 35** **BTN 2: N/A** **No BTN: N/A**

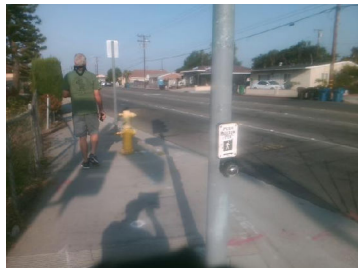
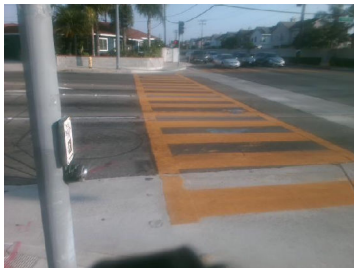
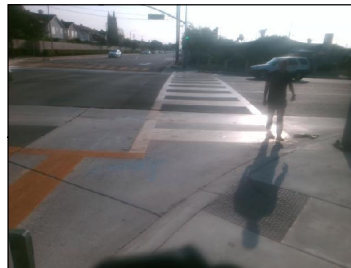
| Compliance | Description | Data | Compliance | Description | Data |
|---|---|---|---|---|---|
| <b>No</b> | B 1 Clear Floor Space Slope (%) | <b>8.7</b> | <b>N/A</b> | B 2 Clear Floor Space Slope (%) | <b>N/A</b> |
| <b>No</b> | B 1 Clear Floor Space XSlope (%) | <b>11</b> | <b>N/A</b> | B 2 Clear Floor Space XSlope (%) | <b>N/A</b> |

**Possible Solutions: Replace Signal Push Button With APS Button. Remove and Replace Clear Space.**
