# Access Compliance Report Public Rights-of-Way (Pedestrian Signals)

Main Street: HAZARD\_AVE Cross Street: NEWLAND\_ST Location: SE

ADA ID: SGRK210929114805 Signal Type: One Push Button-Non APS Overall Compliance: No Severity Scores: BTN 1: 35 BTN 2: N/A No BTN: N/A

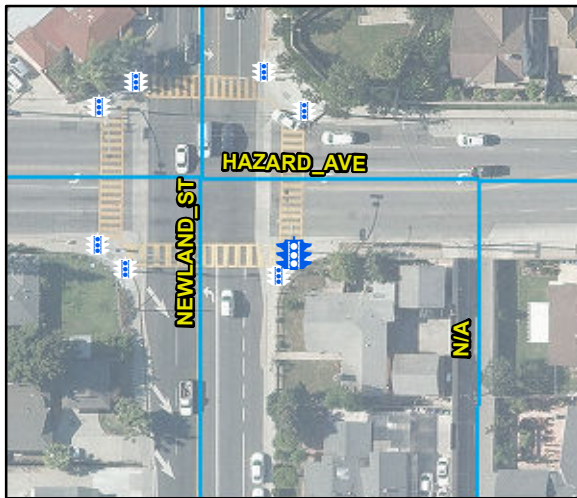
| No B 1 Pilot Light? | No | N/A B 2 Pilot Light? | N/A |

| Compliance | Description | Data | Compliance | Description | Data |
|---|---|---|---|---|---|
| No B 1 Clear Floor Space XSlope (%) | 10.7 | N/A | B 2 Clear Floor Space XSlope (%) | N/A | |

Possible Solutions: Replace Signal Push Button With APS Button. Remove and Replace Clear Space.
