# Access Compliance Report Public Rights-of-Way (Pedestrian Signals)

Main Street: **NEWLAND\_ST** Cross Street: **MADISON\_AVE** Location: **SW**

ADA ID: **SGRK210929123041** Signal Type: **One Push Button-Non APS** Overall Compliance: **No** Severity Scores: **BTN 1: 35** **BTN 2: N/A** **No BTN: N/A**

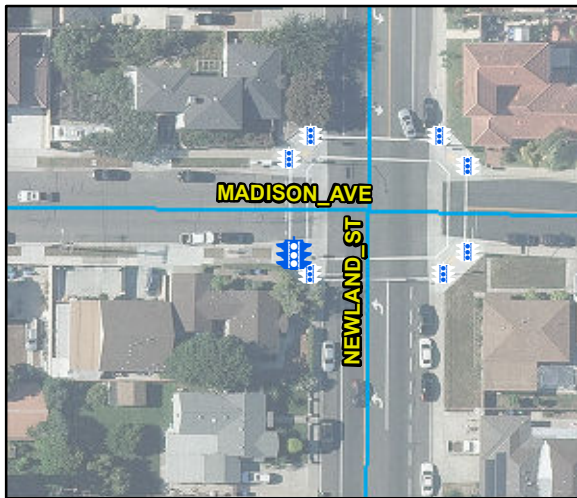
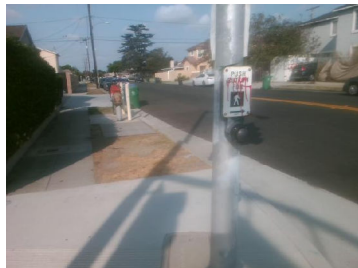
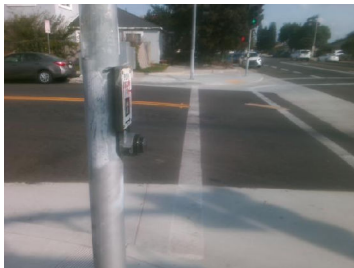
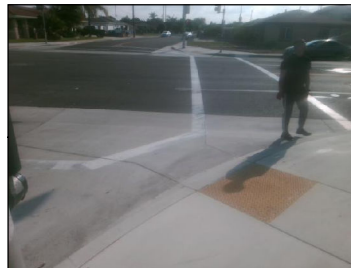
| Compliance | Description | Data | Compliance | Description | Data |
|---|---|---|---|---|---|
| <b>No</b> | B 1 Clear Floor Space XSlope (%) | <b>7.1</b> | <b>N/A</b> | B 2 Clear Floor Space XSlope (%) | <b>N/A</b> |

Possible Solutions: Replace Signal Push Button With APS Button. Remove and Replace Clear Space.

OC Std/PROW: **R404.2, MUTCD 4e.08**
