# Access Compliance Report Public Rights-of-Way (Pedestrian Signals)

Main Street: **MADISON\_AVE** Cross Street: **NEWLAND\_ST** Location: **SE**

ADA ID: **SGRK210929123712** Signal Type: **One Push Button-Non APS** Overall Compliance: **No** Severity Scores: **BTN 1: 35** **BTN 2: N/A** **No BTN: N/A**

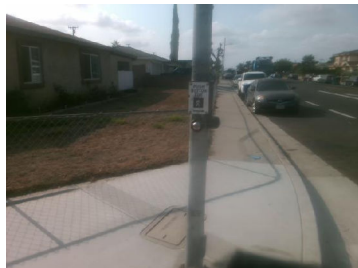
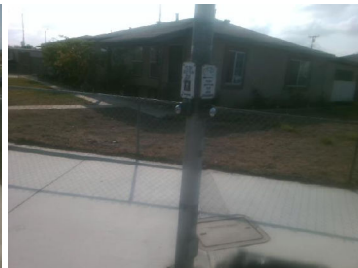
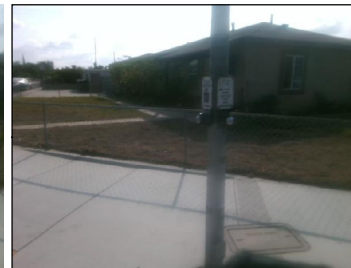
| No B 1 Pilot Light? | No | N/A B 2 Pilot Light? | N/A |

| Compliance | Description | Data | Compliance | Description | Data |
|---|---|---|---|---|---|
| No | B 1 Clear Floor Space Slope (%) | 3.8 | N/A | B 2 Clear Floor Space Slope (%) | N/A |
| No | B 1 Clear Floor Space XSlope (%) | 2.8 | N/A | B 2 Clear Floor Space XSlope (%) | N/A |

Possible Solutions: Replace Signal Push Button With APS Button. Remove and Replace Clear Space.

OC Std/PROW: R404.2, R404.3, MUTCD 4e.08
