# Access Compliance Report Public Rights-of-Way (Pedestrian Signals)

Main Street: **NEWLAND\_ST** Cross Street: **MADISON\_AVE** Location: **NE**

ADA ID: **SGRK210929124540** Signal Type: **One Push Button-Non APS** Overall Compliance: **No** Severity Scores: **BTN 1: 35** **BTN 2: N/A** **No BTN: N/A**

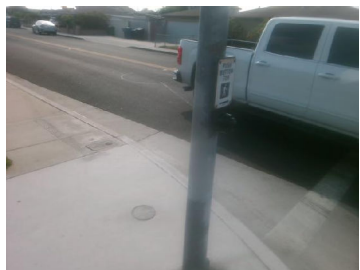
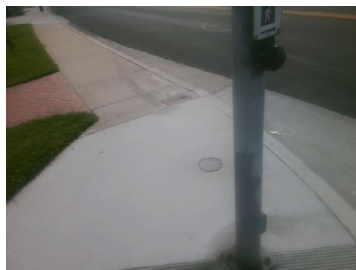
| <b>No</b> B 1 Pilot Light? | <b>No</b> | <b>N/A</b> B 2 Pilot Light? | <b>N/A</b> |

| Compliance | Description | Data | Compliance | Description | Data |
|---|---|---|---|---|---|
| <b>No</b> | B 1 Clear Floor Space Slope (%) | <b>5.4</b> | <b>N/A</b> | B 2 Clear Floor Space Slope (%) | <b>N/A</b> |
| <b>No</b> | B 1 Clear Floor Space XSlope (%) | <b>9.6</b> | <b>N/A</b> | B 2 Clear Floor Space XSlope (%) | <b>N/A</b> |

Possible Solutions: Replace Signal Push Button With APS Button. Remove and Replace Clear Space.

OC Std/PROW: **R404.2, R404.3, MUTCD 4e.08**
