# Access Compliance Report Public Rights-of-Way (Pedestrian Signals)

Main Street: **NEWLAND\_ST** Cross Street: **MADISON\_AVE** Location: **NE**

ADA ID: **SGRK210929124713** Signal Type: **One Push Button-Non APS** Overall Compliance: **No** Severity Scores: **BTN 1: 35** **BTN 2: N/A** **No BTN: N/A**

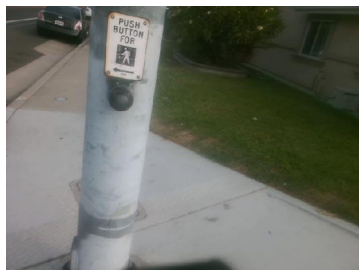
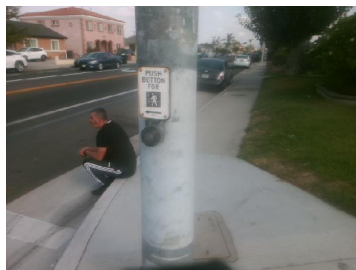
| <b>No</b> B 1 Pilot Light? | <b>No</b> | <b>N/A</b> B 2 Pilot Light? | <b>N/A</b> |

| Compliance | Description | Data | Compliance | Description | Data |
|---|---|---|---|---|---|
| <b>No</b> | B 1 Clear Floor Space Slope (%) | <b>3.1</b> | <b>N/A</b> | B 2 Clear Floor Space Slope (%) | <b>N/A</b> |
| <b>No</b> | B 1 Clear Floor Space XSlope (%) | <b>7.8</b> | <b>N/A</b> | B 2 Clear Floor Space XSlope (%) | <b>N/A</b> |

Possible Solutions: Replace Signal Push Button With APS Button. Remove and Replace Clear Space.
