# Access Compliance Report Public Rights-of-Way (Pedestrian Signals)

Main Street: **NEWLAND\_ST** Cross Street: **BOLSA\_AVE** Location: **NW**

ADA ID: **SGRK210929125617** Signal Type: **One Push Button-Non APS** Overall Compliance: **No** Severity Scores: **BTN 1: 35** **BTN 2: N/A** **No BTN: N/A**

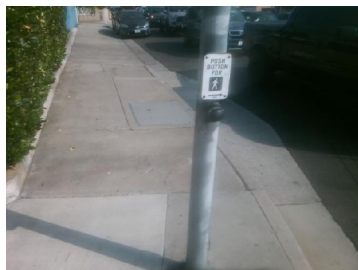
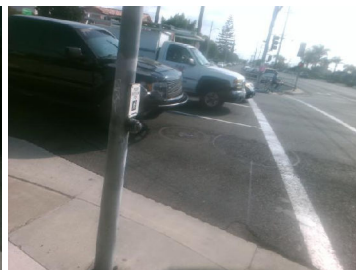
| Compliance | Description | Data | Compliance | Description | Data |
|---|---|---|---|---|---|
| <b>No</b> B 1 Clear Floor Space Slope (%) | | <b>3.5</b> | <b>N/A</b> | B 2 Clear Floor Space Slope (%) | <b>N/A</b> |
| <b>No</b> B 1 Clear Floor Space XSlope (%) | | <b>2.6</b> | <b>N/A</b> | B 2 Clear Floor Space XSlope (%) | <b>N/A</b> |
| <b>No</b> B 1 DistanceTo XWalk (in) | | <b>68</b> | <b>N/A</b> | B 2 DistanceTo XWalk (in) | <b>N/A</b> |

Possible Solutions: Replace Signal Push Button With APS Button. Remove & Relocate Sign.

OC Std/PROW: MUTCD 4e.08, R404.2, R404.3
