# Access Compliance Report Public Rights-of-Way (Pedestrian Signals)

Main Street: BOLSA\_AVE Cross Street: VAN\_BUREN\_ST Location: NW

ADA ID: SGRK210930110615 Signal Type: One Push Button-Non APS Overall Compliance: No Severity Scores: BTN 1: 25 BTN 2: N/A No BTN: N/A

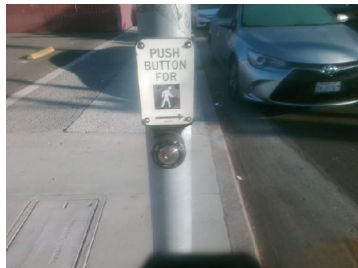
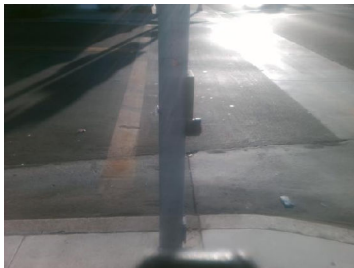
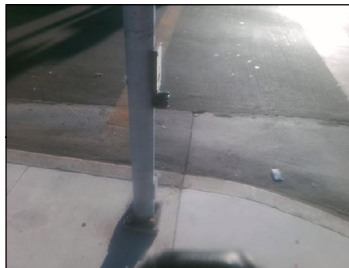
| Compliance | Description | Data | Compliance | Description | Data |
|---|---|---|---|---|---|
| No B 1 Clear Floor Space XSlope (%) | | 4.5 | N/A | B 2 Clear Floor Space XSlope (%) | N/A |

Possible Solutions: Replace Signal Push Button With APS Button. Remove & Relocate Sign.
