# Access Compliance Report Public Rights-of-Way (Pedestrian Signals)

Main Street: MCFADDEN\_AVE Cross Street: BEACH\_BLVD Location: SE

ADA ID: SGRK211005145805 Signal Type: One Push Button-APS Overall Compliance: No Severity Scores: BTN 1: 25 BTN 2: N/A No BTN: N/A

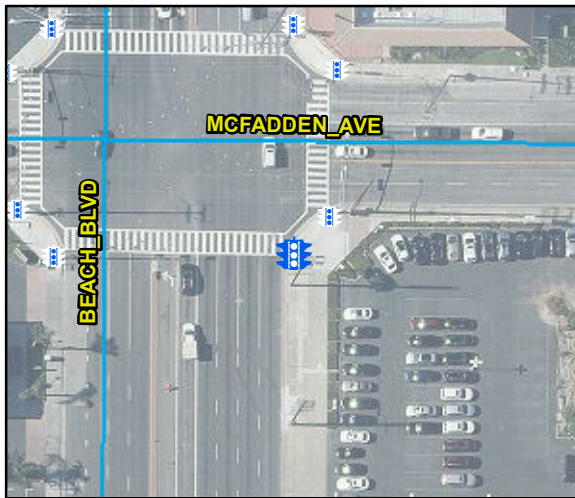
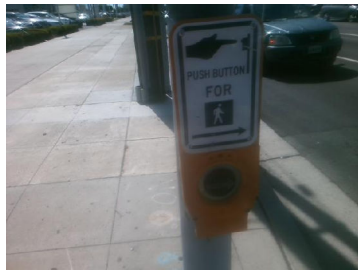
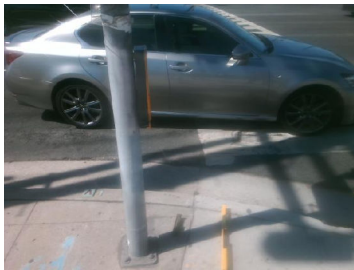
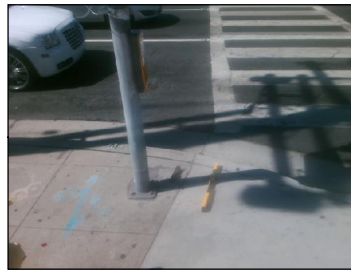
| Compliance | Description | Data | Compliance | Description | Data |
|---|---|---|---|---|---|
| No B 1 Clear Floor Space XSlope (%) | | 3.8 | N/A | B 2 Clear Floor Space XSlope (%) | N/A |

Possible Solutions: Remove and Replace Clear Space.

OC Std/PROW: R404.2

Total Cost: \$ 378
