# Access Compliance Report Public Rights-of-Way (Pedestrian Signals)

Main Street: MCFADDEN\_AVE Cross Street: BEACH\_BLV Location: SE

ADA ID: SGRK211005150039 Signal Type: One Push Button-Non APS Overall Compliance: No Severity Scores: BTN 1: 35 BTN 2: N/A No BTN: N/A

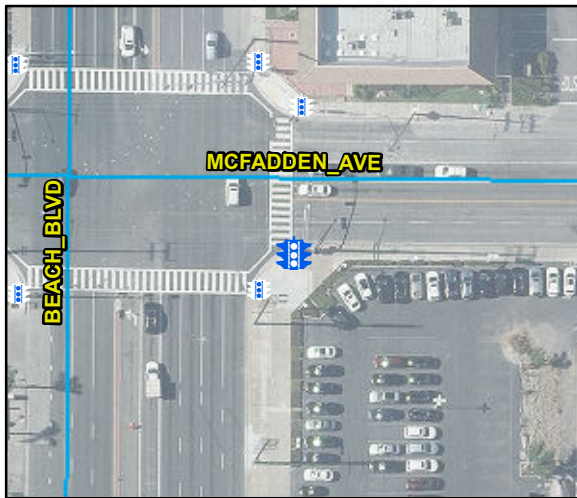
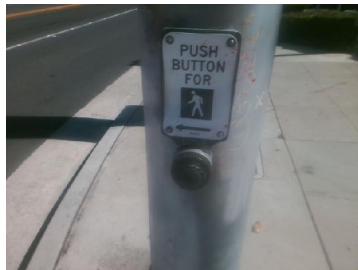
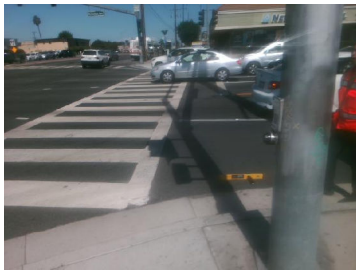
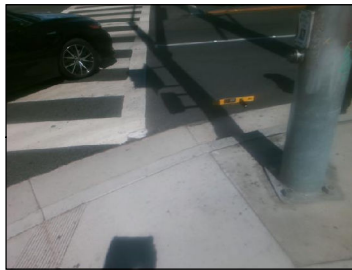
| No B 1 Pilot Light? | No | N/A B 2 Pilot Light? | N/A |

| Compliance | Description | Data | Compliance | Description | Data |
|---|---|---|---|---|---|
| No B 1 Clear Floor Space Slope (%) | | 5.4 | N/A | B 2 Clear Floor Space Slope (%) | N/A |
| No B 1 Clear Floor Space XSlope (%) | | 4.8 | N/A | B 2 Clear Floor Space XSlope (%) | N/A |

Possible Solutions: Replace Signal Push Button With APS Button. Remove and Replace Clear Space.

OC Std/PROW: R404.2, R404.3, MUTCD 4e.08

Total Cost: \$ 1278
