# Access Compliance Report Public Rights-of-Way (Pedestrian Signals)

Main Street: MCFADDEN\_AVE Cross Street: MCFADDEN\_AVE Location: N

ADA ID: SGRK211005181026 Signal Type: One Push Button-APS Overall Compliance: No Severity Scores: BTN 1: 25 BTN 2: N/A No BTN: N/A

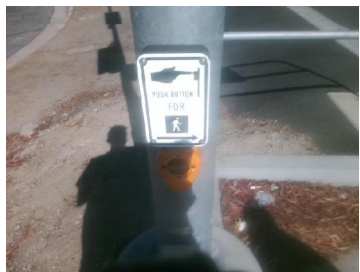
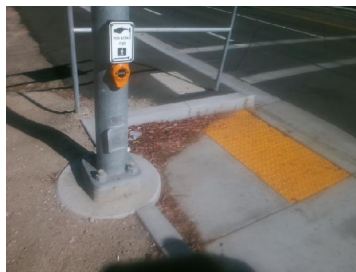
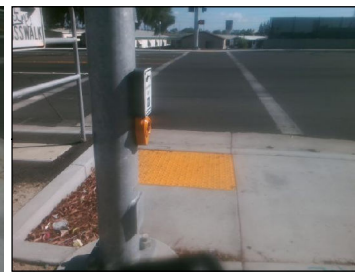
| Compliance | Description | Data | Compliance | Description | Data |
|---|---|---|---|---|---|
| No | B 1 Clear Floor Space XSlope (%) | 2.8 | N/A | B 2 Clear Floor Space XSlope (%) | N/A |
| No | B 1 DistanceTo Curb (in) | 84 | N/A | B 2 DistanceTo Curb (in) | N/A |

Possible Solutions: Replace Signal Push Button With APS Button. Remove & Relocate Sign.

Total Cost: \$ 650
