# Access Compliance Report Public Rights-of-Way (Pedestrian Signals)

Main Street: **BROWNING\_AVE** Cross Street: **IRVINE\_BLVD** Location: **SE**

ADA ID: **SGRK211006110338** Signal Type: **One Push Button-APS** Overall Compliance: **No** Severity Scores: **BTN 1: 25** **BTN 2: N/A** **No BTN: N/A**

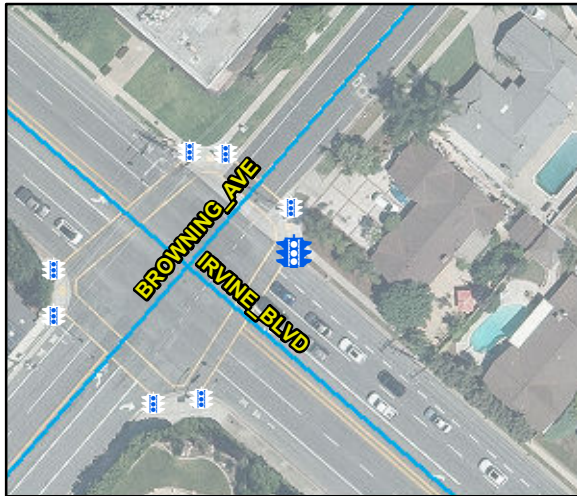
| Compliance | Description | Data | Compliance | Description | Data |
|---|---|---|---|---|---|
| No B 1 Clear Floor Space XSlope (%) | | 4.5 | N/A | B 2 Clear Floor Space XSlope (%) | N/A |

Possible Solutions: Remove and Replace Clear Space.

OC Std/PROW: **R404.2**

Total Cost: \$ **378**
