# Access Compliance Report Public Rights-of-Way (Pedestrian Signals)

Main Street: IRVINE\_BLVD Cross Street: BROWNING\_AVE Location: SW

ADA ID: SGRK211006112242 Signal Type: One Push Button-APS Overall Compliance: No Severity Scores: BTN 1: 25 BTN 2: N/A No BTN: N/A

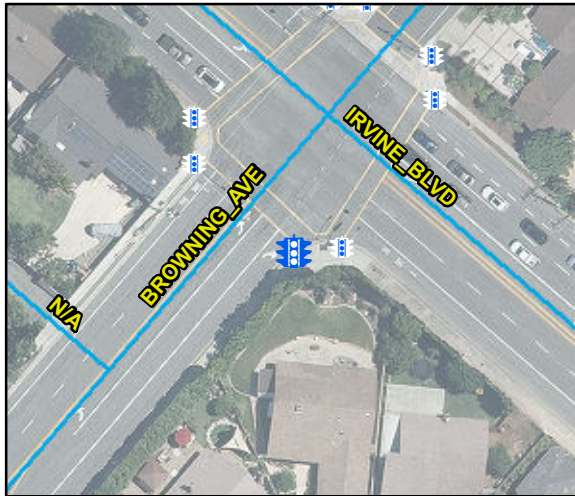
OC Std/PROW: R404.2

| Compliance | Description | Data | Compliance | Description | Data |
|---|---|---|---|---|---|
| No B 1 Clear Floor Space XSlope (%) | 3.9 | N/A | B 2 Clear Floor Space XSlope (%) | N/A | |

Possible Solutions: Remove and Replace Clear Space.
