# Access Compliance Report

## Public Rights-of-Way

### (Pedestrian Signals)

Main Street: FAIRHAVEN\_AVE Cross Street: ESPLANADE\_AVE Location: SE

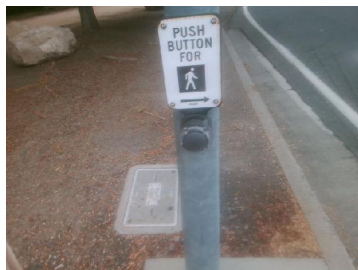
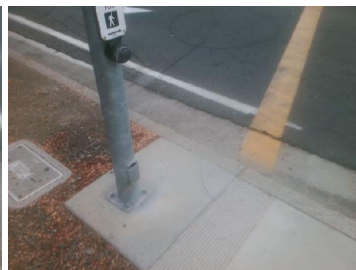
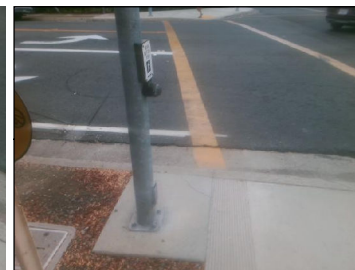
ADA ID: SGRK211007111420 Signal Type: One Push Button-Non APS Overall Compliance: No Severity Scores: BTN 1: 35 BTN 2: N/A No BTN: N/A

| No B 1 Pilot Light? | No | N/A B 2 Pilot Light? | N/A |

| Compliance | Description | Data | Compliance | Description | Data |
|---|---|---|---|---|---|
| No B 1 Clear Floor Space XSlope (%) | 5.5 | N/A | B 2 Clear Floor Space XSlope (%) | N/A | |

Possible Solutions: Replace Signal Push Button With APS Button. Remove and Replace Clear Space.
