# Access Compliance Report Public Rights-of-Way (Pedestrian Signals)

Main Street: FAIRHAVEN\_AVE Cross Street: FAIRHAVEN\_AVE Location: NW

ADA ID: SGRK211007112341 Signal Type: One Push Button-Non APS Overall Compliance: No Severity Scores: BTN 1: 35 BTN 2: N/A No BTN: N/A

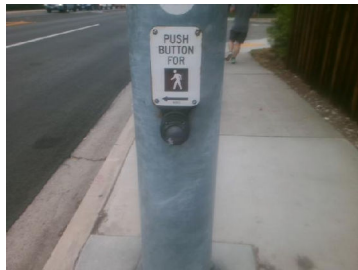
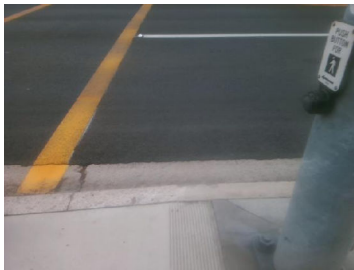
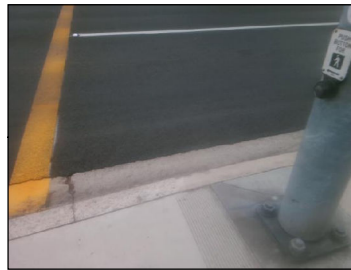
| No B 1 Pilot Light? | No | N/A B 2 Pilot Light? | N/A |

| Compliance | Description | Data | Compliance | Description | Data |
|---|---|---|---|---|---|
| No | B 1 Clear Floor Space Slope (%) | 5 | N/A | B 2 Clear Floor Space Slope (%) | N/A |
| No | B 1 Clear Floor Space XSlope (%) | 3.9 | N/A | B 2 Clear Floor Space XSlope (%) | N/A |
| No | B 1 DistanceTo XWalk (in) | 70 | N/A | B 2 DistanceTo XWalk (in) | N/A |

Possible Solutions: Replace Signal Push Button With APS Button. Remove & Relocate Sign.

Total Cost: \$ 650
