# Access Compliance Report Public Rights-of-Way (Pedestrian Signals)

Main Street: 17TH\_ST Cross Street: ESPLANADE\_AVE Location: NW

ADA ID: SGRK211007121507 Signal Type: One Push Button-APS Overall Compliance: No Severity Scores: BTN 1: 25 BTN 2: N/A No BTN: N/A

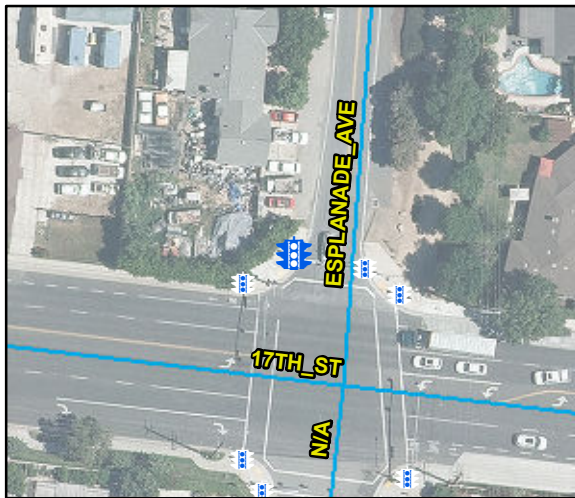
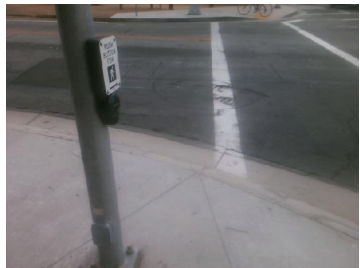
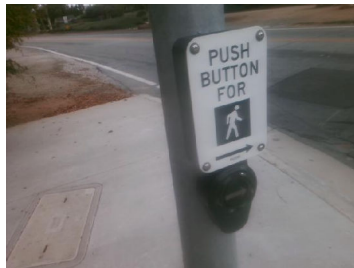
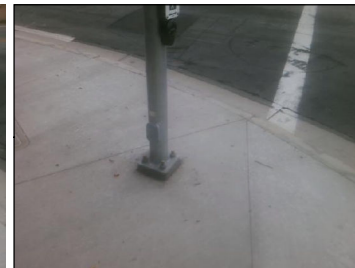
| Compliance | Description | Data | Compliance | Description | Data |
|---|---|---|---|---|---|
| No B 1 Clear Floor Space XSlope (%) | 11.6 | N/A | B 2 Clear Floor Space XSlope (%) | N/A | |

Possible Solutions: Remove and Replace Clear Space.

OC Std/PROW: R404.2
