# Access Compliance Report Public Rights-of-Way (Pedestrian Signals)

Main Street: **EL CAMINO\_LN** Cross Street: **NEWPORT\_AVE** Location: **SW**

ADA ID: **SGRK211007132159** Signal Type: **One Push Button-Non APS** Overall Compliance: **No** Severity Scores: **BTN 1: 25** **BTN 2: N/A** **No BTN: N/A**

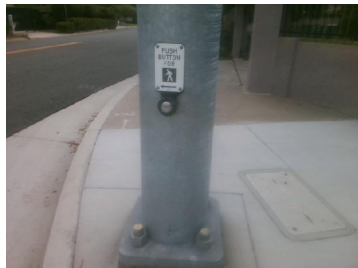
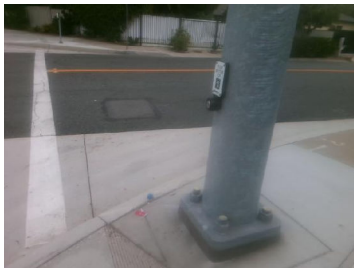
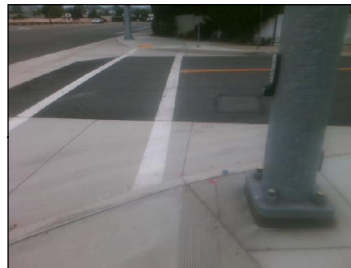
| Compliance | Description | Data | Compliance | Description | Data |
|---|---|---|---|---|---|
| <b>No</b> | B 1 Clear Floor Space XSlope (%) | <b>9.8</b> | <b>N/A</b> | B 2 Clear Floor Space XSlope (%) | <b>N/A</b> |

Possible Solutions: Remove and Replace Clear Space.

OC Std/PROW: **R404.2**

Total Cost: \$ **378**
