# Access Compliance Report

## Public Rights-of-Way

### (Pedestrian Signals)

Main Street: 17TH\_ST Cross Street: 17TH\_ST Location: SE

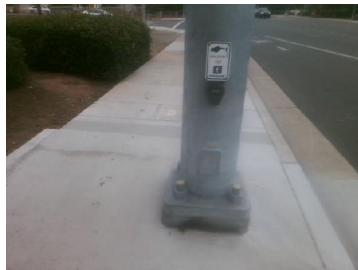
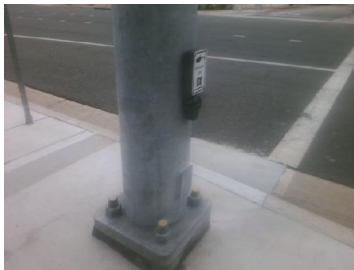
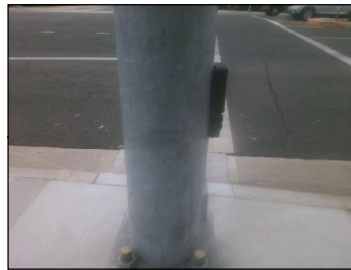
ADA ID: SGRK211007145035 Signal Type: One Push Button-APS Overall Compliance: No Severity Scores: BTN 1: 25 BTN 2: N/A No BTN: N/A

| Compliance | Description | Data | Compliance | Description | Data |
|---|---|---|---|---|---|
| No | B 1 Clear Floor Space XSlope (%) | 12.1 | N/A | B 2 Clear Floor Space XSlope (%) | N/A |

Possible Solutions: Remove and Replace Clear Space.

Total Cost: \$ 378
